# 2019 Sewer Master Plan Update

Prepared for San Bernardino Municipal Water Department

March 2020

Stantec Consulting

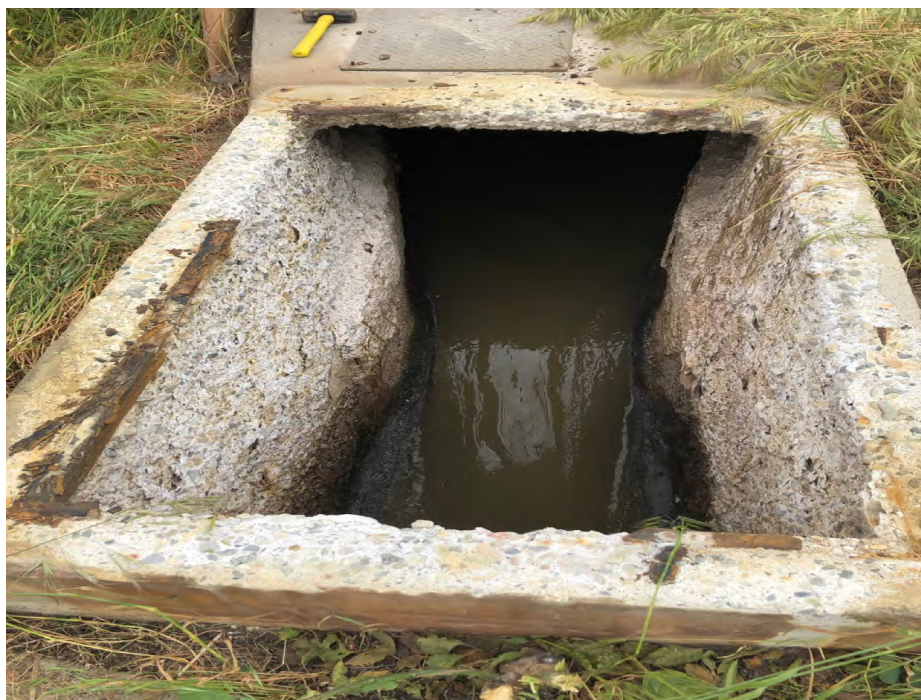
**Figure 10-4: Concrete Structure on Pipeline 08700140860134**

These pipelines have recent CCTV available and the adjusted risk score is based on CCTV results, with the exception of 08700140860134. That pipeline would be included in the future CCTV recommendation, however, a structure discovered on this pipeline by SBMWD staff warranted detailed study. According to SBMWD staff, the Old Headworks Facility concrete structure located east of the WRP and the Twin Creek Channel and south of Dumas Street shows visible concrete and rebar damage that appears to be Level 4 on V&A's Vanda Concrete Corrosion Index Rating System. This location is shown on Figure 10-4.
